## **Weekly Summary Report**

### **USEPA Oversight, Sauget Area 2, Sauget, IL**

### **WA No. 224-RXBF-05XX / Contract No. 68-W6-0025**

**Week Ending Friday November 7, 2003**

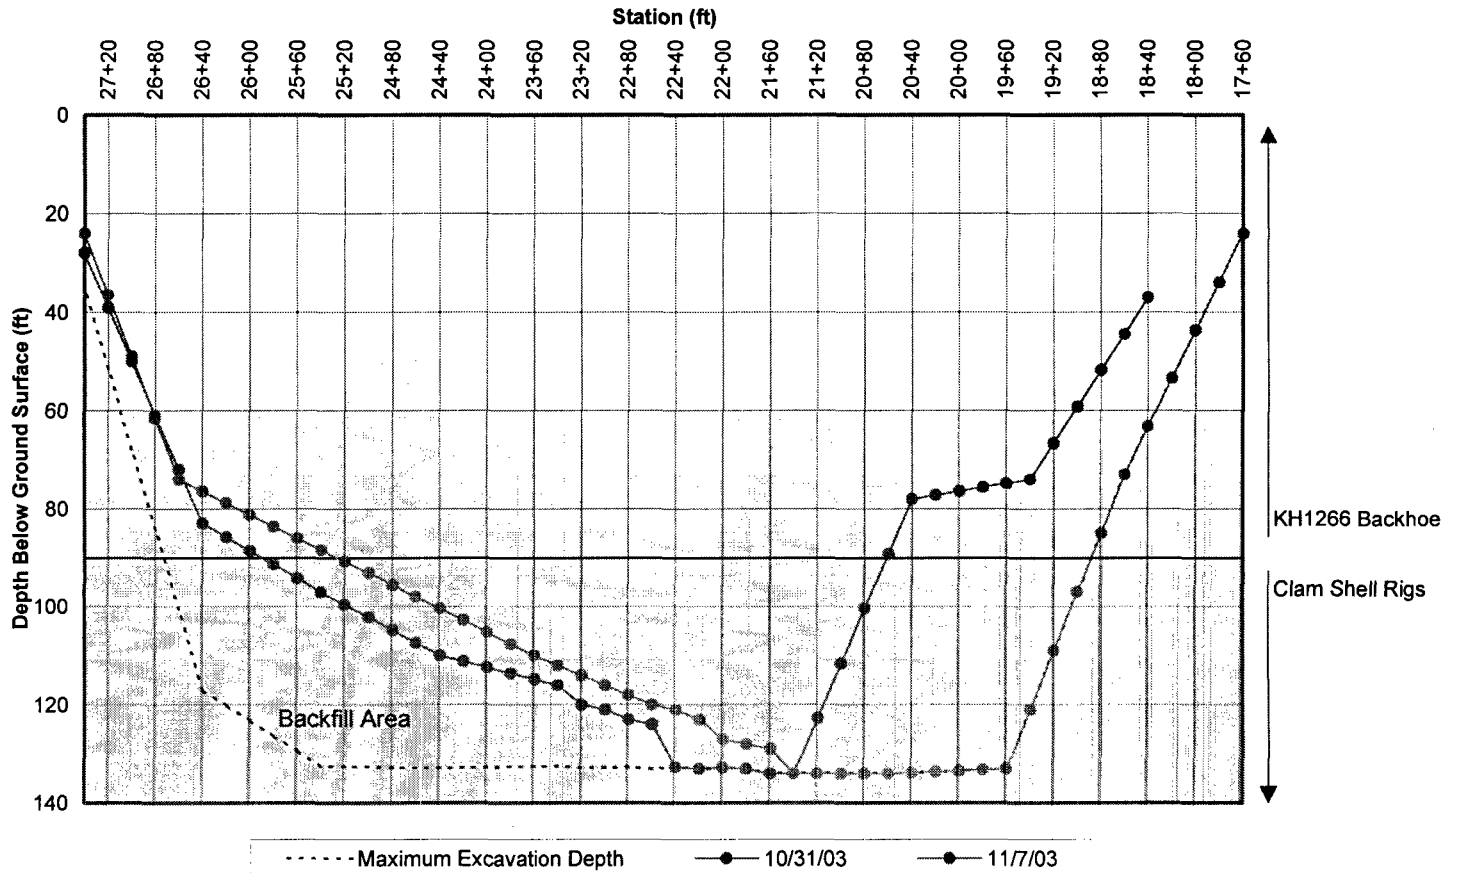
Trench depths continued to be measured once daily (AM) during the week and every 100 linear feet of trench with 20-foot spacing of measurements delineating the toe of the backfill. The morning trench depth measurements from November 7 that depict the weekly progress are shown in Table 1. Construction progress by November 7, 2003 is shown below. Graph 1 shows the progress of the trench in comparison to the previous week. Graph 2 shows the overall progress of the barrier wall construction.

### Weekly Barrier Wall Construction Progress Nov. 1st to Nov. 7th 2003

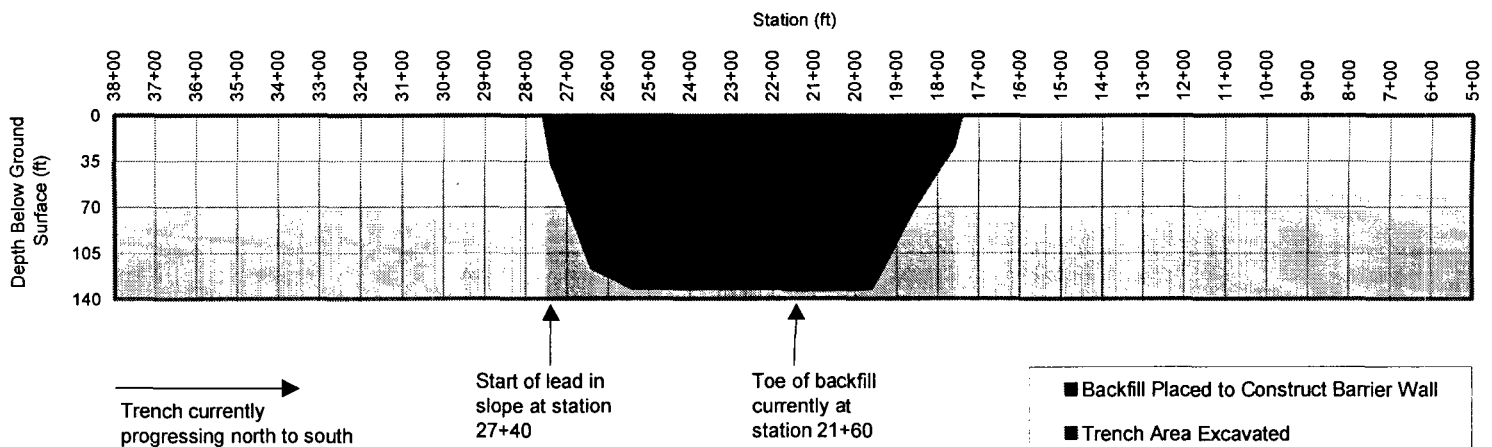
Graph 2

### Barrier Wall Construction Progress by November 7, 2003

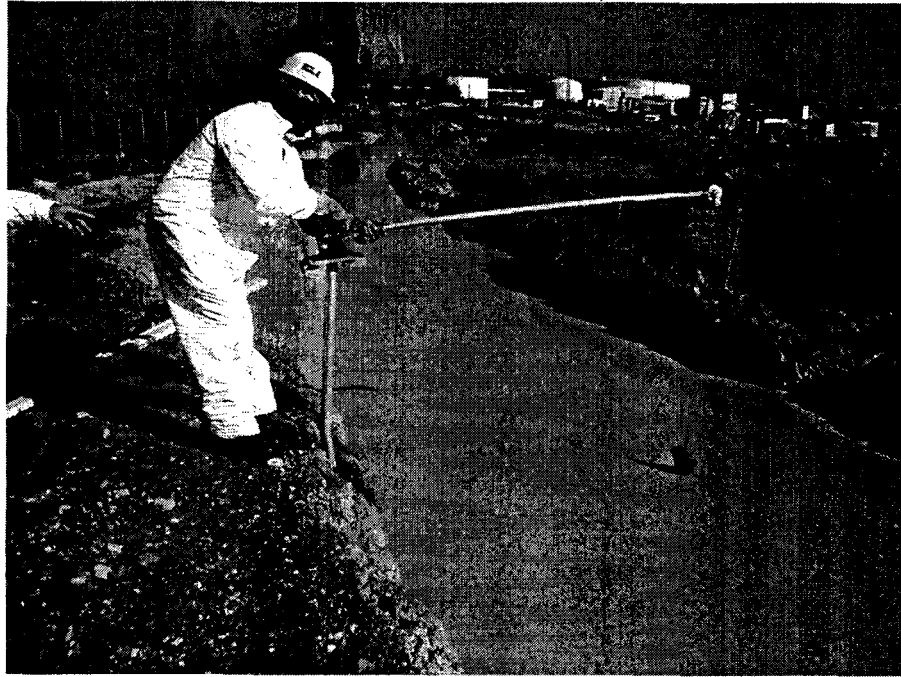
Zahner Survey were onsite November 1, 2003 installing 'elevation hubs' every 10 feet along the side of the open trench. The elevation hubs were then used during trench cleaning as a reference point for the total trench depth. Thus, starting November 3, the trench depth was verified using the downrigger and referenced to a surveyed elevation. Prior to November 3,

Measuring trench depth with downrigger (November 3, 2003).

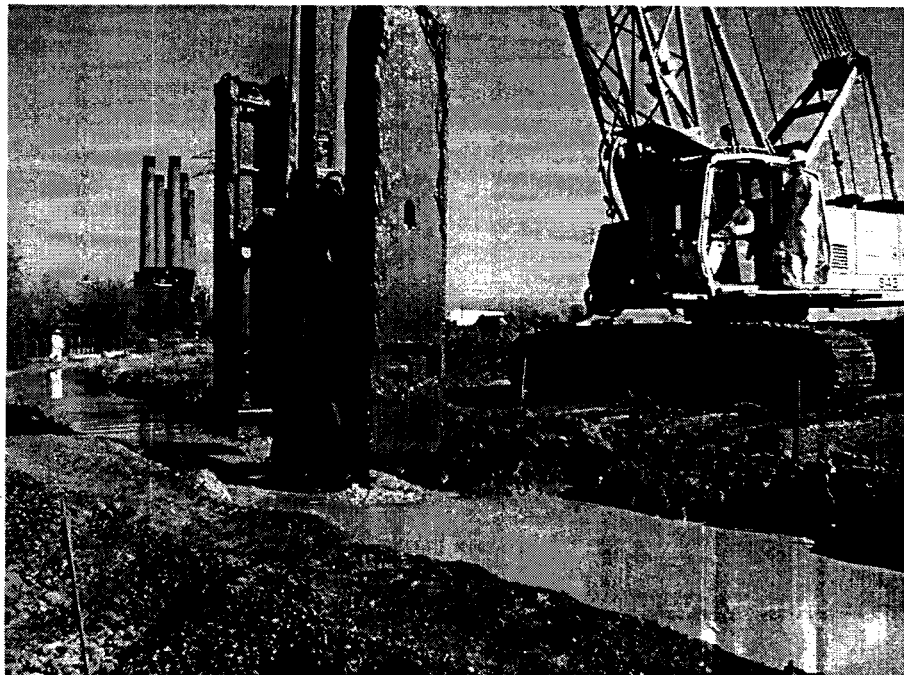
Prior to the backfill operation, the bottom of trench was cleaned thoroughly using one of the clamshell rigs. Depth-to-bottom measurements were made every 10 linear feet of trench to ensure the bottom of the trench was at a consistent depth and on top of bedrock. These depth measurements were performed with the clamshell rig's instrumentation and confirmed in two locations manually with the downrigger (plumbob and tape). Additionally, two samples with a clam sampler were collected by URS and PSI from the top of the placed backfill in the trench prior to adding more backfill. These backfill samples were visually checked to ensure that the trench bottom was clean and free of any sand.

Cleaning the trench with clamshell rig, prior to backfill (November 3, 2003).
